Dealing with Heritage

Assessment and Conservation

**Barbara Lubelli
Uta Potgiesser
Wido Quist
Susanne Rexroth**

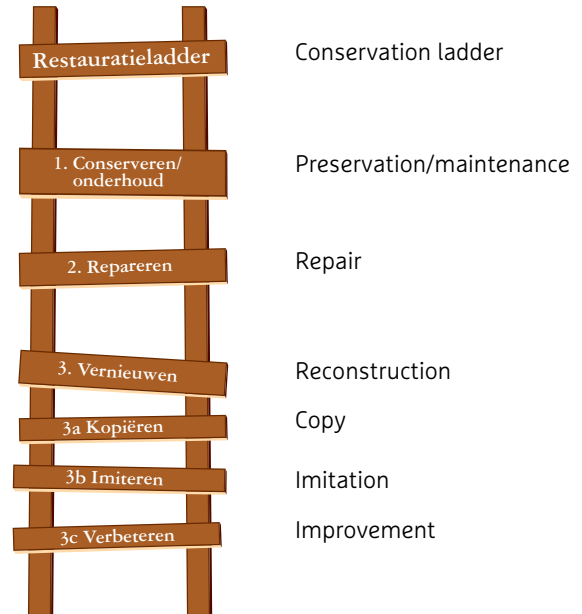
FIG. 1.3 ERM Restauratieladder (with English translation)

The ERM has developed the ‘conservation ladder’ for Dutch restoration practice [FIG. 1.3]. This instrument is helpful in formulating variants for a certain intervention and in determining the most important characteristics on the basis of which a choice can be made (www.stichtingerm.nl). The ladder consists of three steps with a preferred sequence of (1) preservation/maintenance, (2) repair and (3) reconstruction, each taken while keeping the following considerations in mind:

- *Minimal intervention*
(as much as needed, as little as possible)
- *Solidity / durability*
(determining the service life of the intervention)
- *Compatibility*
– In principle the materials used for an intervention should be weaker than the original material
- Replace as much as possible with similar materials or with alike materials and/or alike techniques

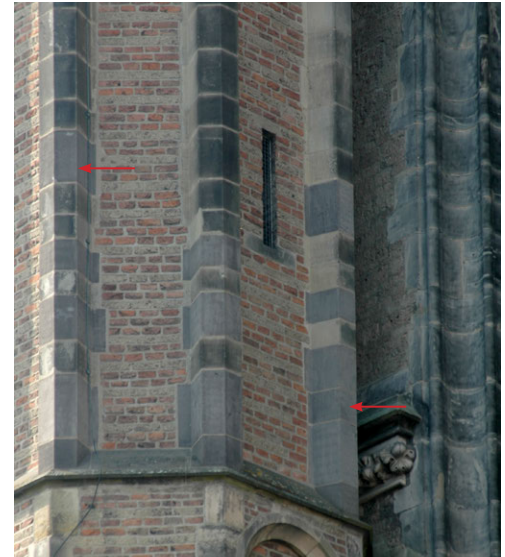
FIG. 2.9 Volvic basalt on the stair tower of the south transept of the Dom Church in Utrecht, as a replacement for Bentheim sandstone / Photo: W.J. Quist

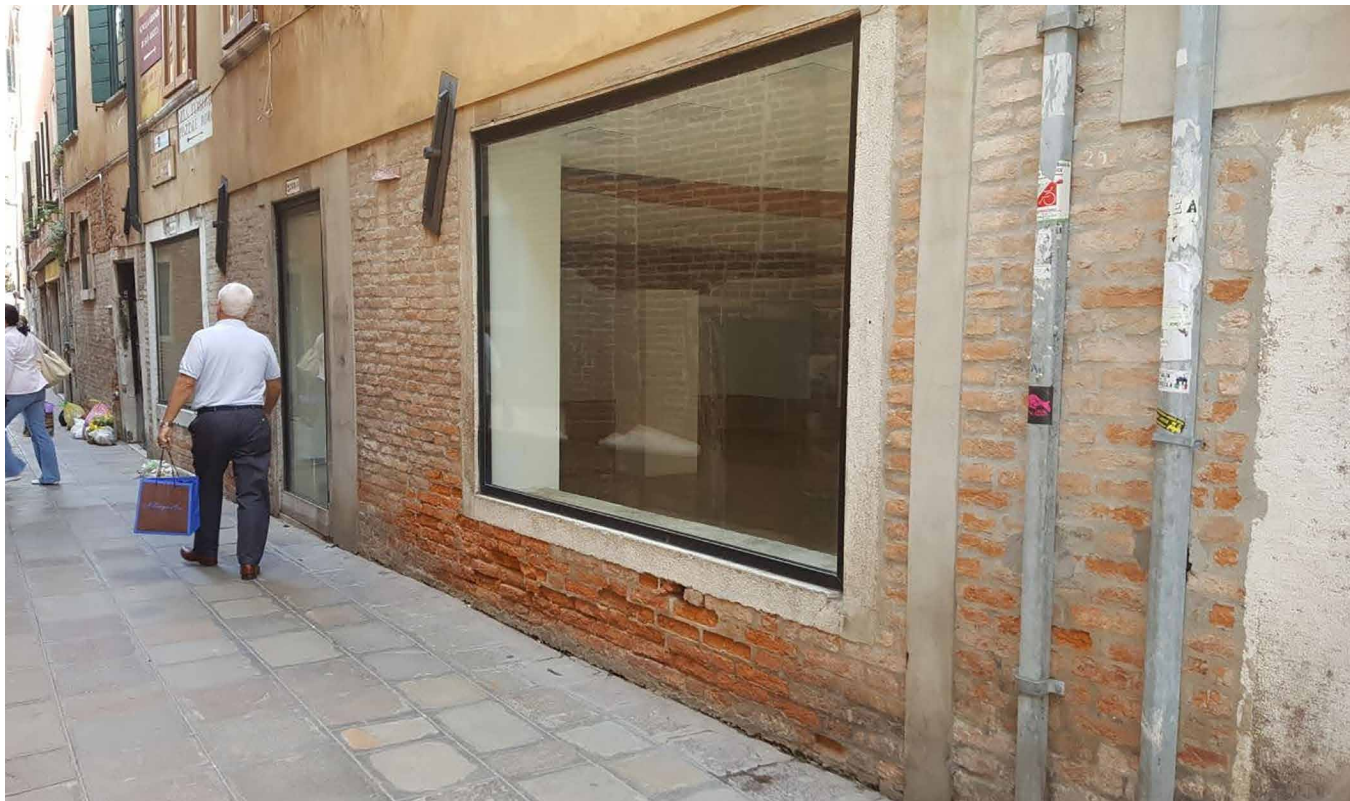
FIG. 3.1 Salt crystallization damage due to the presence of salts and rising damp, Venice, Italy / Photo: B. Lubelli

The phenomenon of rising damp is more common in old than in new constructions due to the fact that historic buildings often have masonry foundations and lack of a damp-proof course, i.e. a layer hindering the water transport from the ground to the upper part of the structure. The high moisture content deriving from the presence of rising damp does not only create an unpleasant and sometimes unhealthy climate in a building, but it also considerably enhances decay processes in the materials composing the wall, as for example the rotting of wooden beams and salt crystallization [FIG. 3.1]. and/or frost damage to brick and mortar. Unfortunately, due to climate changes (e.g. increased frequency of precipitation events with long and intense rainy periods, increased salinity of ground water), the occurrence and the relevance of rising damp will probably increase in the coming decades (Nijland et al., 2009; Brimblecombe, 2010; Sabbioni et al., 2010; Horowitz et al., 2016).

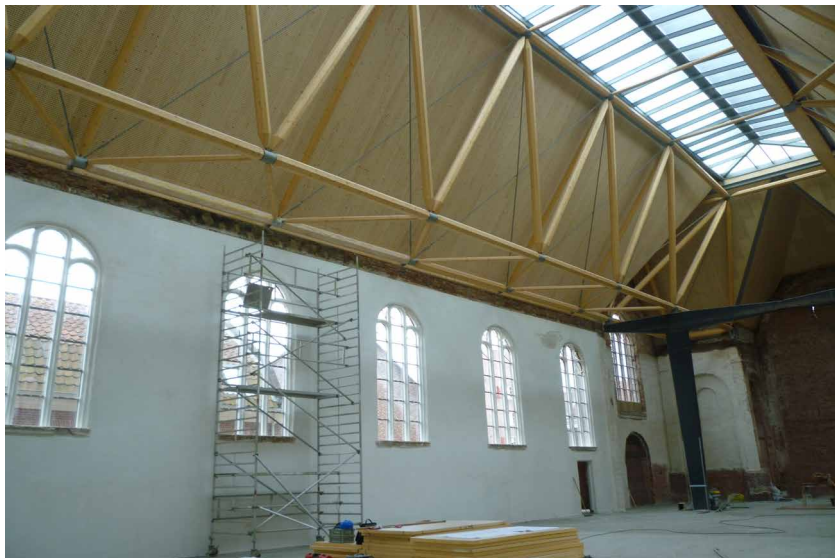
FIG. 3.12 Interior of the Elleboog church: water used to extinguish a fire had accumulated on the concrete floor and risen up in the wall, leading to a moisture content distribution similar to that observed in the presence of rising damp from groundwater / Photo: B. Lubelli

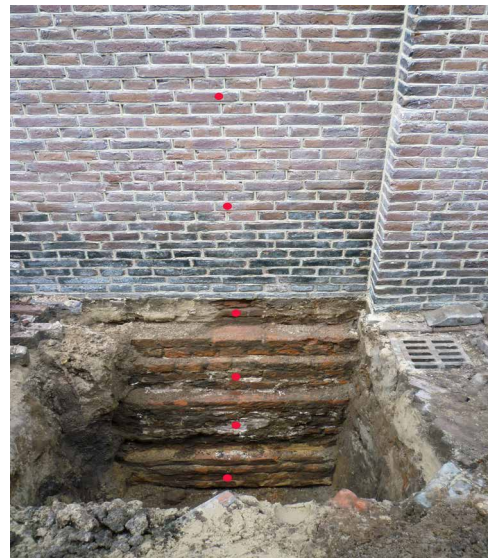
FIG. 3.13 Excavation of the ground around the foundation of the church and sampling, at different depths and heights in the wall along a vertical profile, for the measurement of the moisture content and distribution / Photo: B. Lubelli

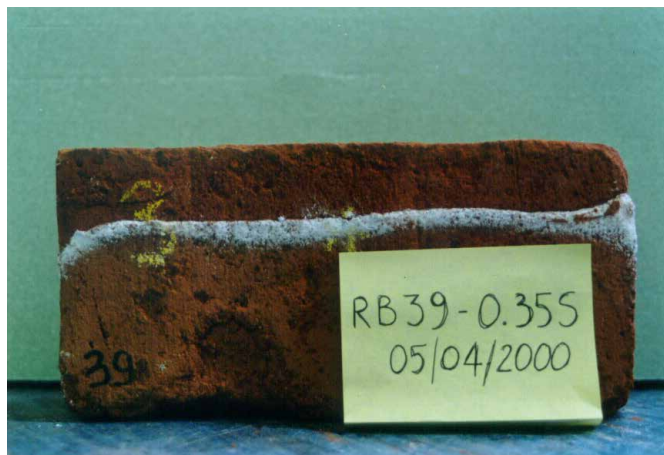
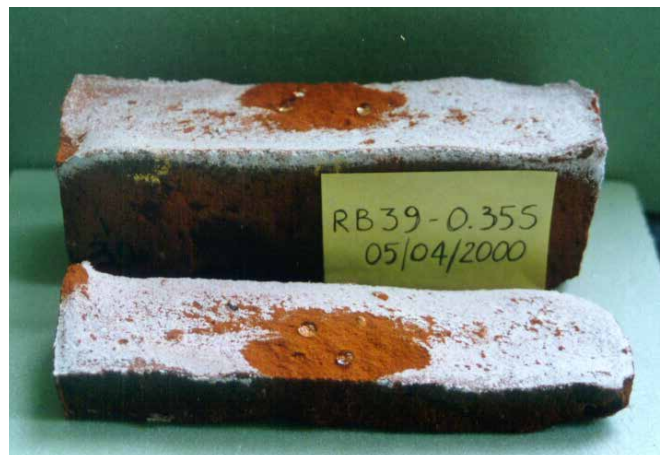
FIGS. 4.12/4.13 Salt accumulation beneath the layer treated with a water repellent (left) and subsequent spalling of the treated part (right) during a laboratory test / Photos: B. Lubelli

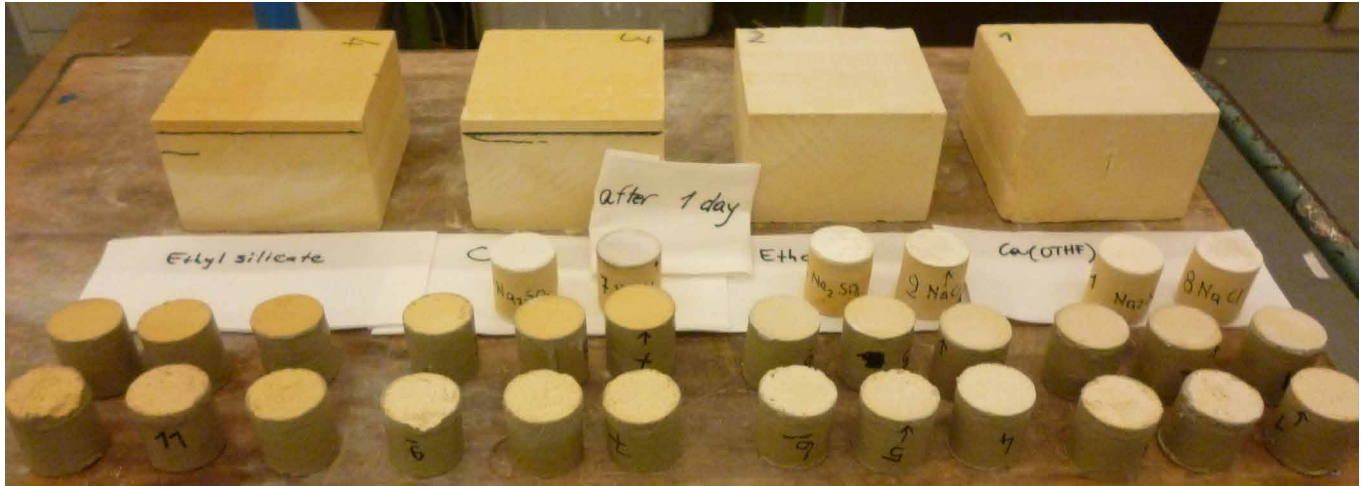
FIG. 4.23 Maastricht limestone 1 day after the application of different consolidation products: product 2 and to a lesser degree product 1, have caused whitening of the surface / Photo: B. Lubelli

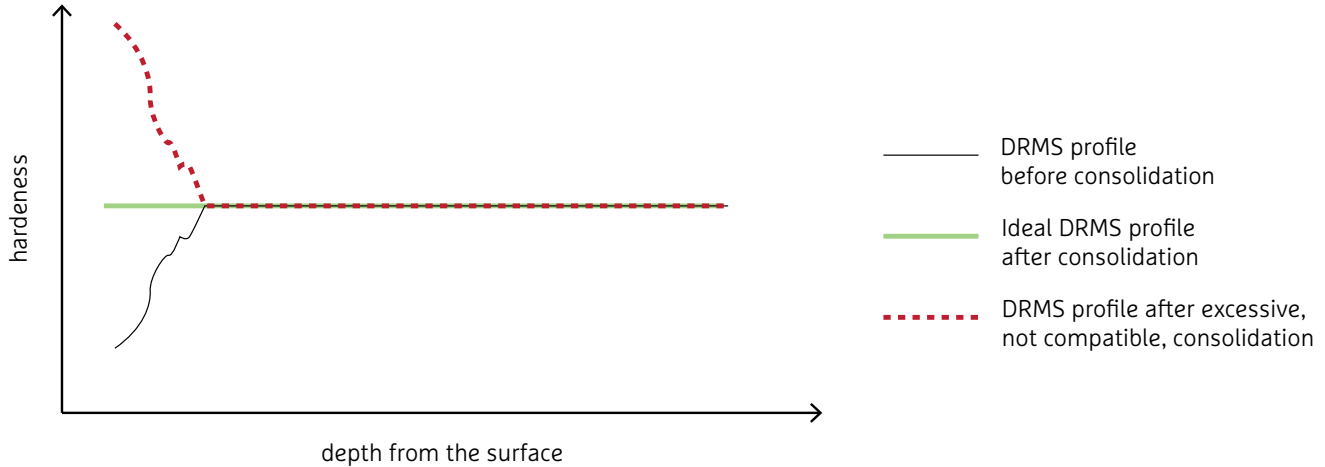
FIG. 4.24 After consolidation the stone should ideally recover its initial hardness (green DRMS profile)

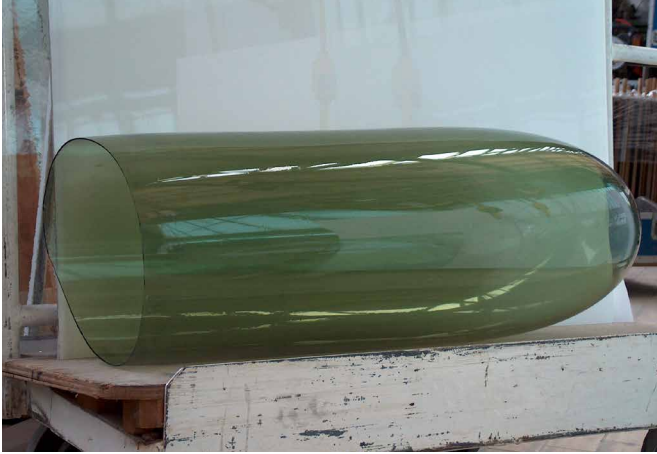
FIG. 5.5 Cylinder glass was another common glass types until 19th century / Photo: RCE

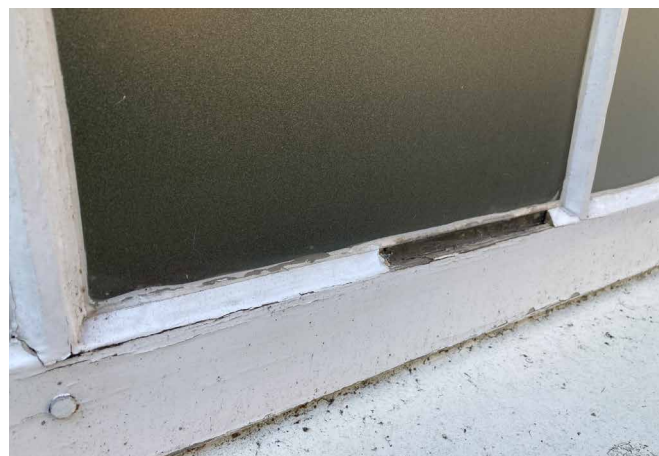
FIG. 5.18 Puttyed glass in wooden windowframe (in need of repair) / Photo: W. J. Quist

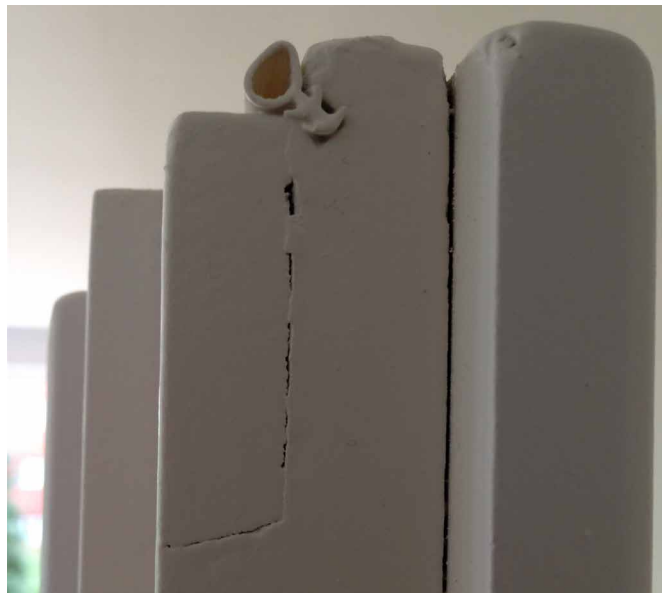
FIG. 5.28 Sash frame with new sealing: a) Image and b) schematic drawing / Photo: S. Rexroth

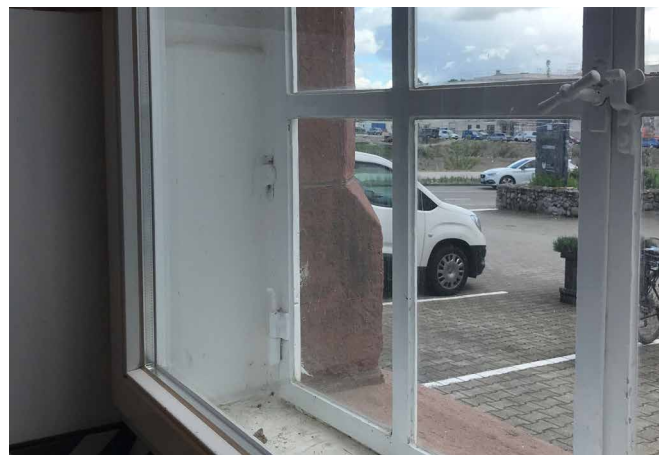
FIG. 5.37 a) Single steel windows with new secondary wood-framed glazing at the interior and b) scheme / Photo: S. Rexroth

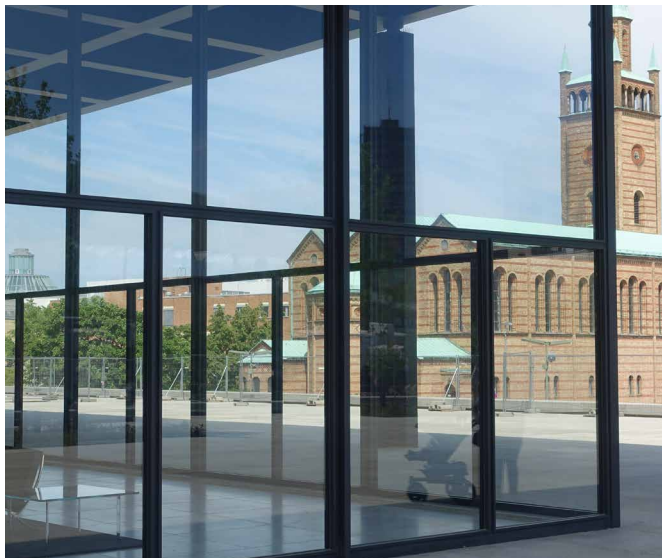
FIG. 5.39 New National Gallery, Berlin: original glazing (above) and three variants for the rehabilitation. In order to avoid glass breakage in the future, a double-thick laminated safety glass (2 x 12 mm) was used (second variant from above). The other two variants would have distorted the appearance of the construction too much. / Photo: F. May
